FZ8MG.xx.xx.xx

Summary of Firmware Releases

FZ8MG.04.04.00 General Release

FZ8MG.04.03.00 General Release

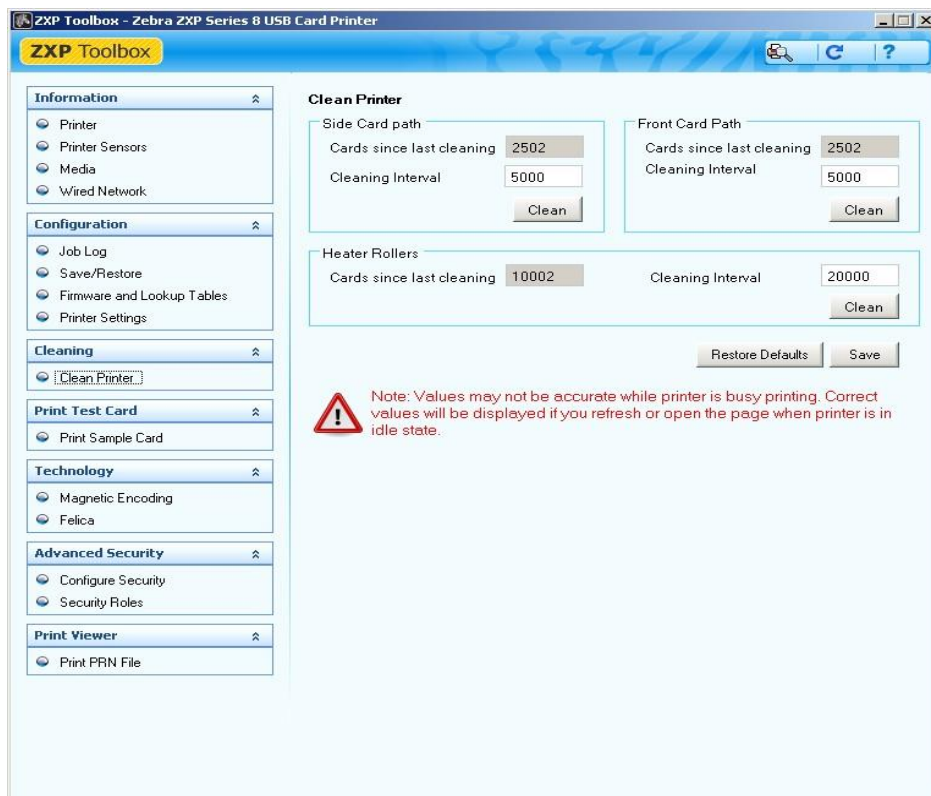
Due to the nature of certain firmware changes made in version 4.03.00, when upgrading the ZXP8 firmware from an older version of firmware, the user may notice a change in some values related to cleaning the printer. As reported in the Toolbox, the values for “Cards since last cleaning” will now be set to one-half of the “Cleaning Interval” value.

In the example below, the firmware was upgraded, the counts were reset to one-half of the cleaning intervals (2500, 2500, and 10000, for the Side Card Path, Front Card Path, and Heater Rollers, respectively), and two cards were printed, resulting in the values seen below.
